Piper Aircraft, Inc.  
2926 Piper Drive  
Vero Beach, FL, U.S.A. 32960

# SERVICE NO. 1317C BULLETIN

**AFT WING SPAR INSPECTION**

PA-46-600TP M600

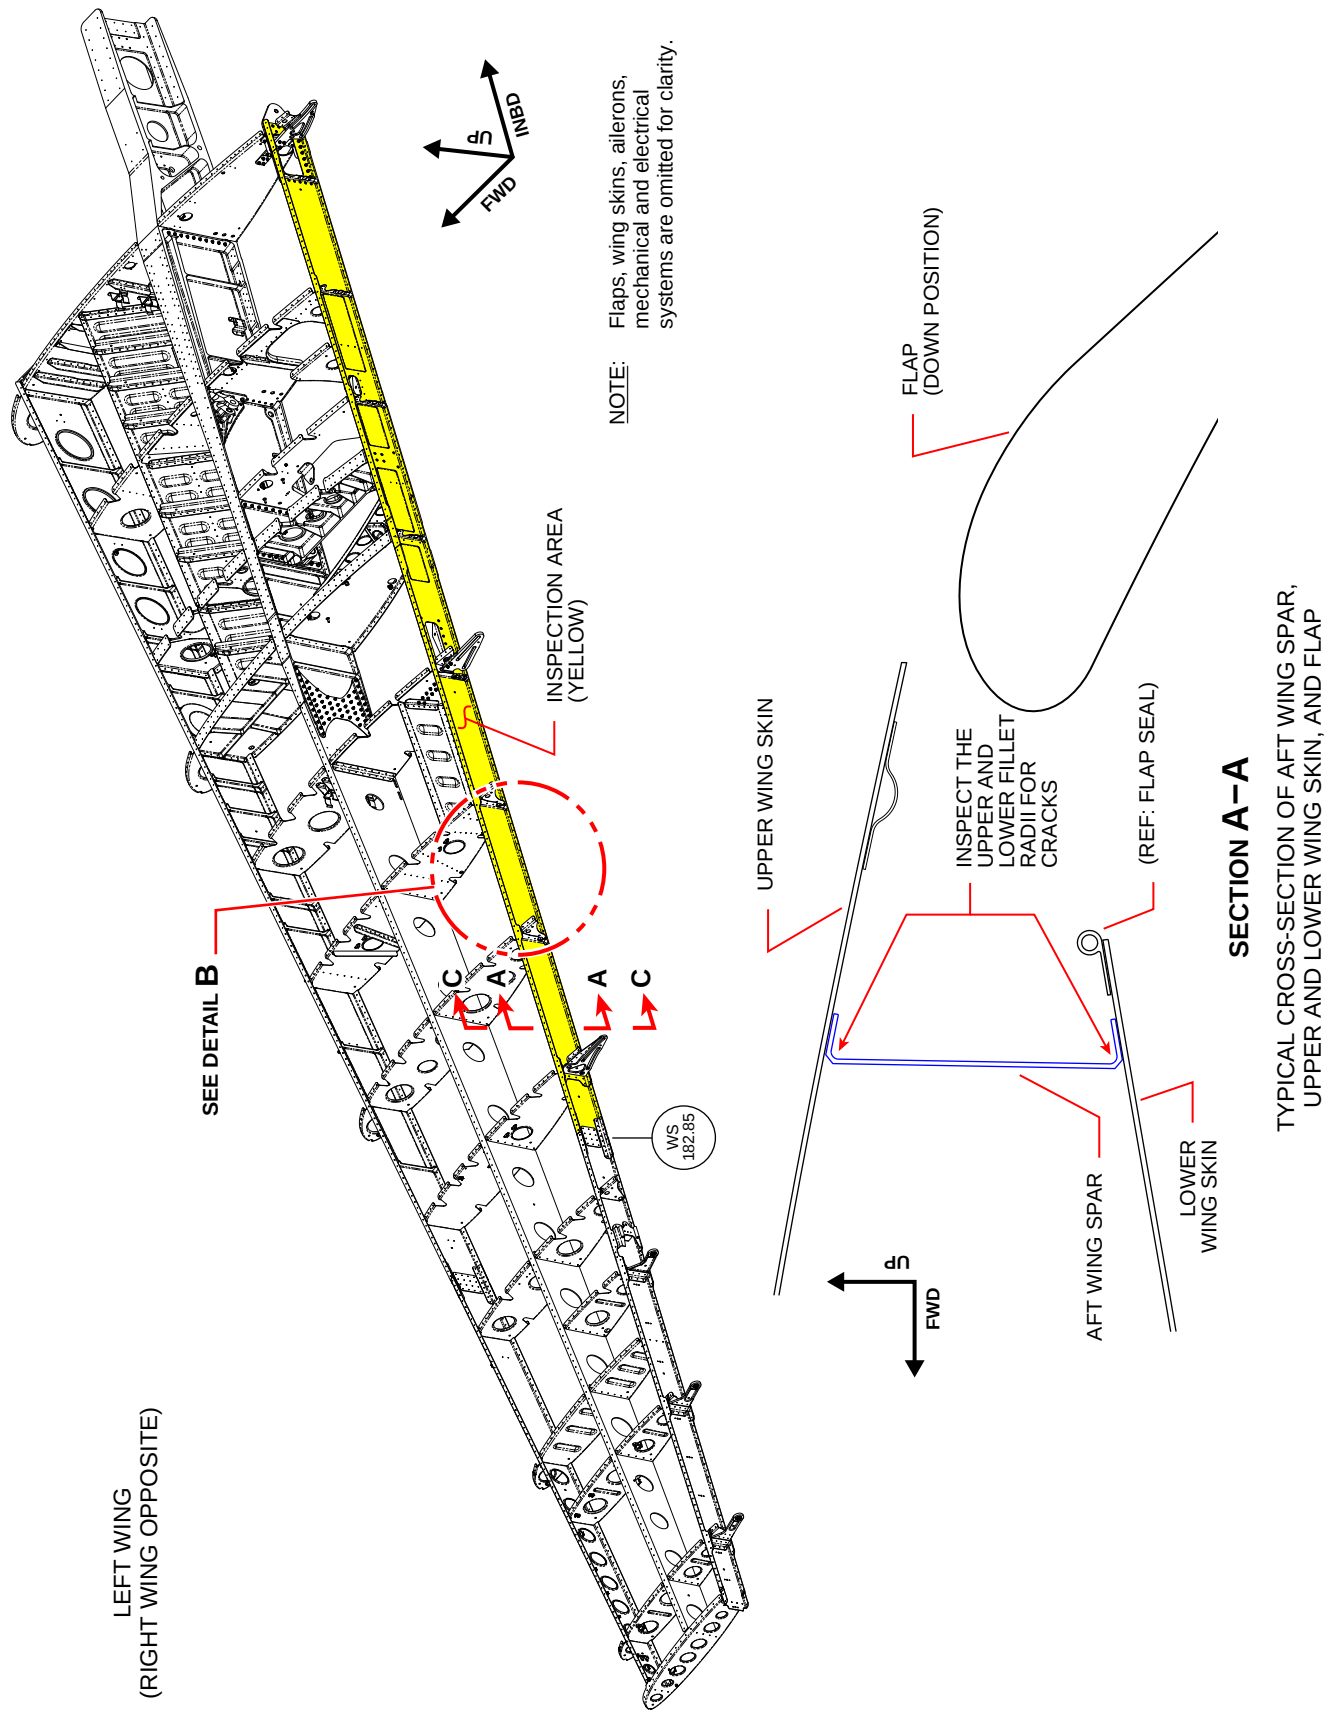
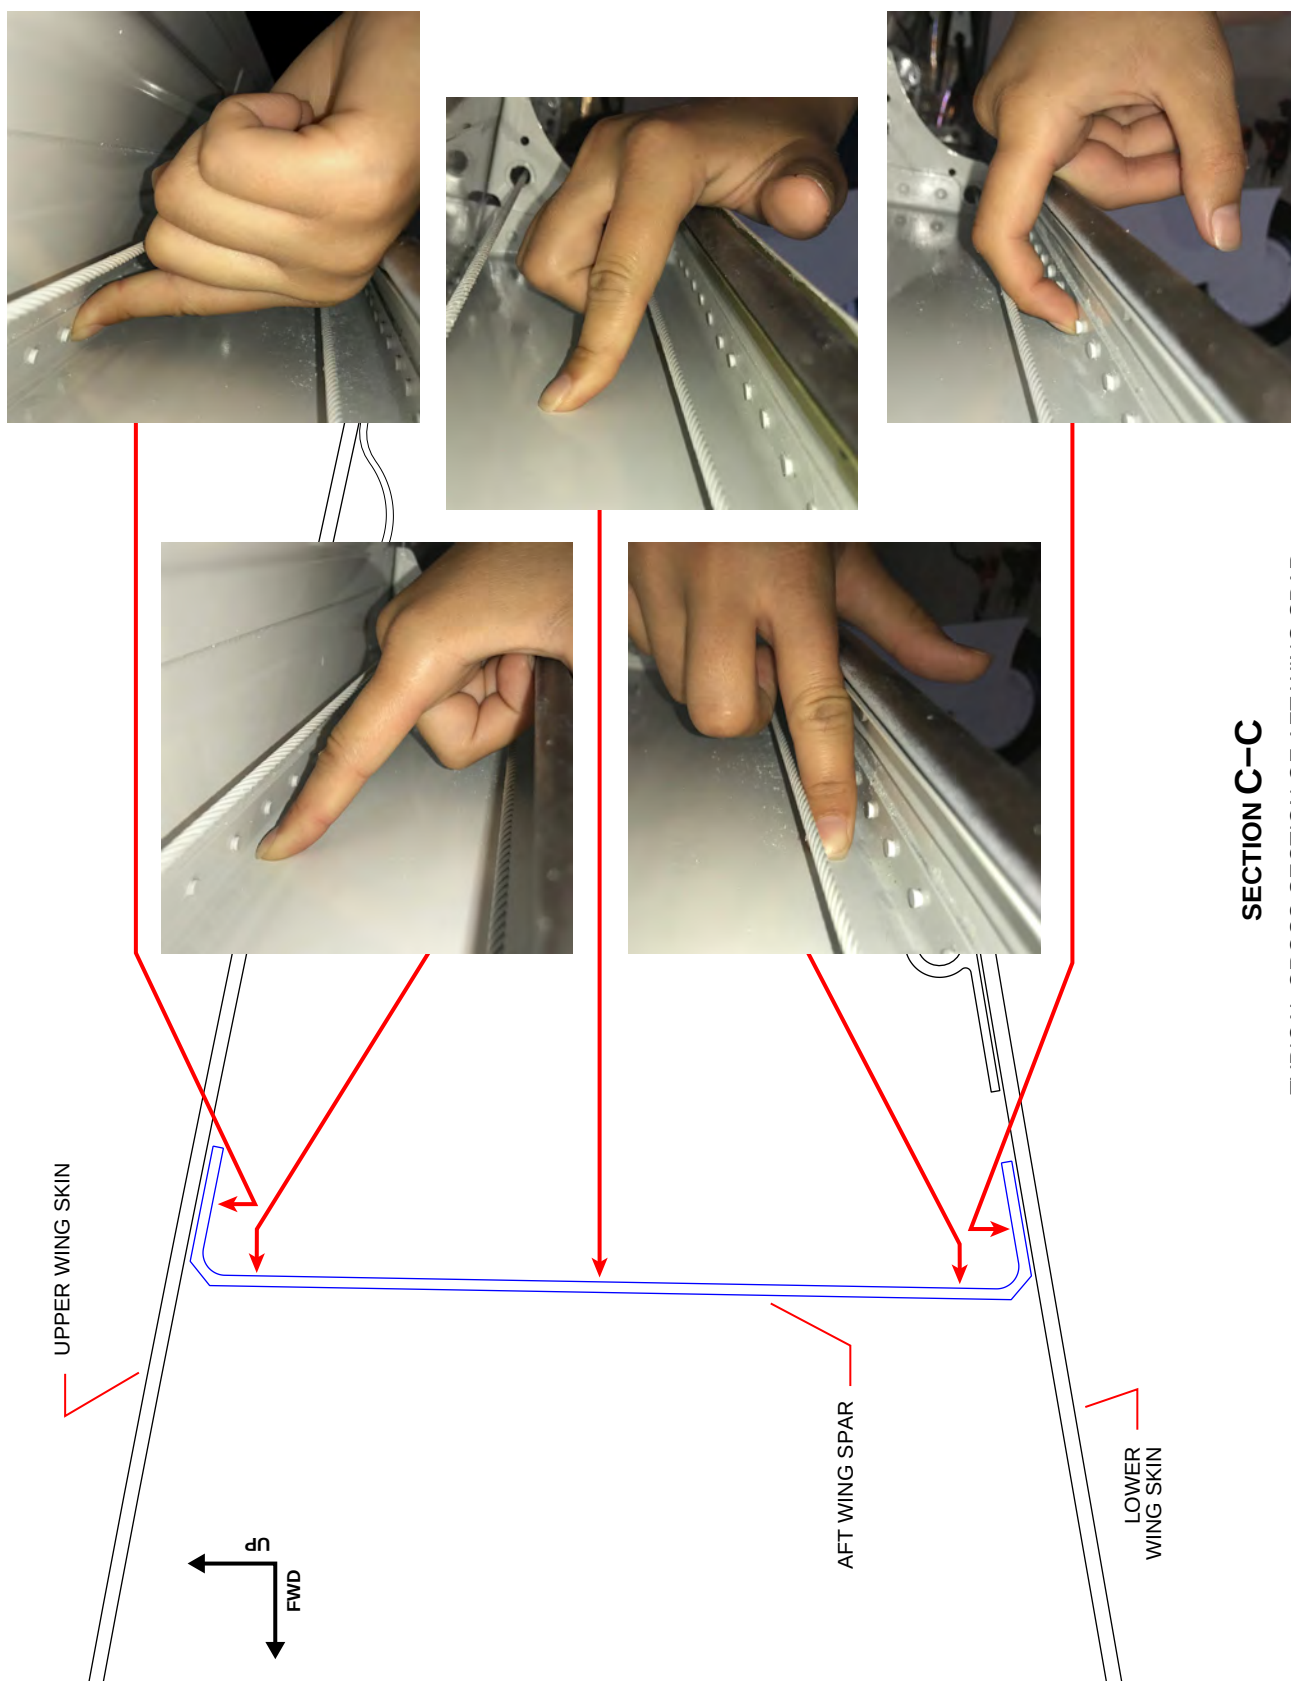
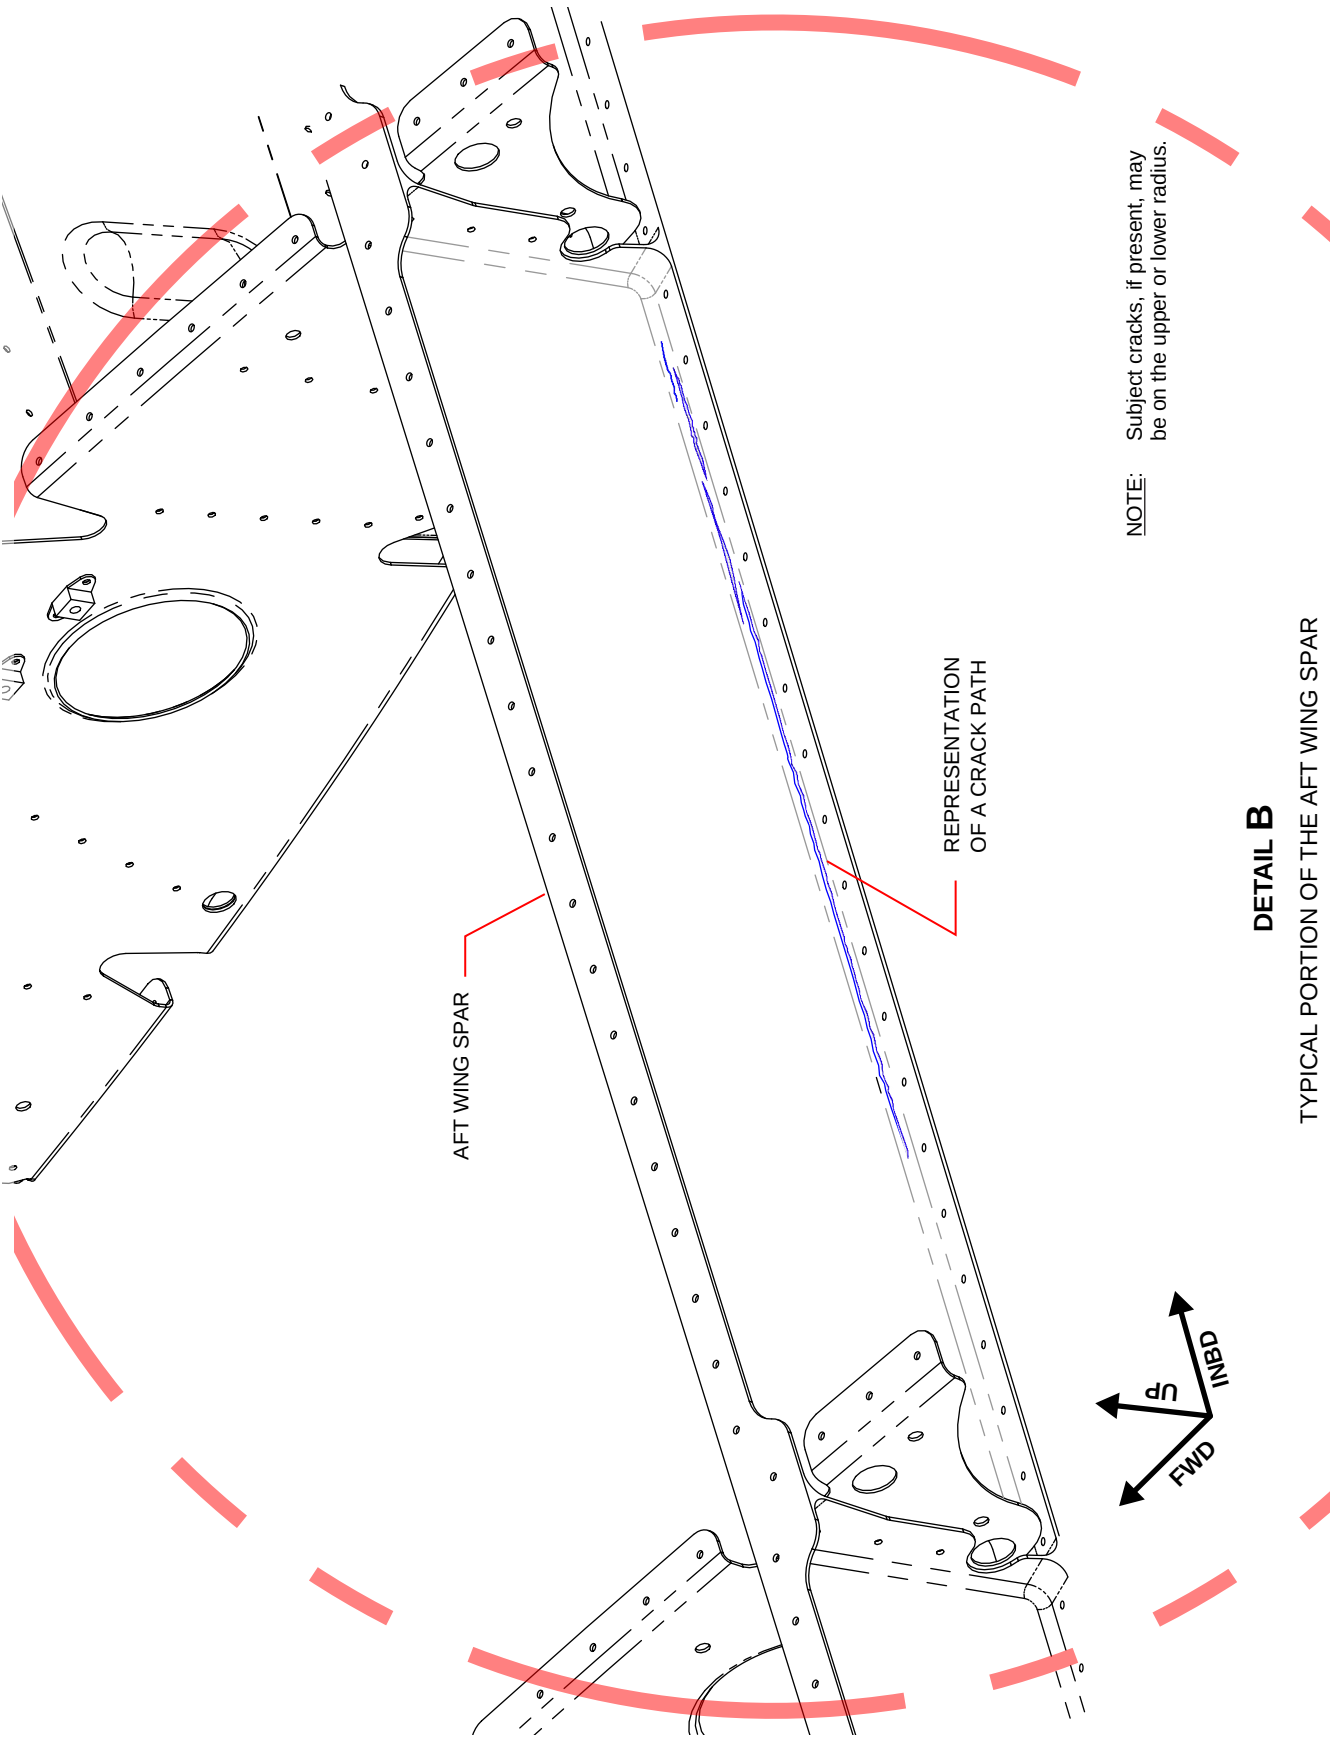
Figure 1, Sheet 1  
Aft Wing Spar – Visual Inspection

- a. Prior to inspection, wipe surfaces clean using a soft cloth dampened with isopropyl alcohol, mineral spirits, naphtha, or other suitable cleaning agent or method.
- b. Locate the area of inspection, which is shown in Figure 1. This area (highlighted in yellow in Figure 1) begins at the aft spar outboard splice at wing station (WS) 182.85 and extends inboard to the wing root.

- c. Visually inspect the area of the aft wing spar identified in Figure 1 for cracks:

Apply finger pressure to the aft wing spar web and flanges at locations midway between ribs, looking for any displacement that would reveal a crack. Refer to Figure 1, Section C–C.

Any crack, if present, will likely follow a path as shown in Figure 1, Detail B, along the upper and/or lower radius.

- If cracks **are not found**, proceed to Step 2.
- **If any crack is found**, an FAA approved repair must be accomplished prior to next flight. Contact Piper for disposition (contact information follows).

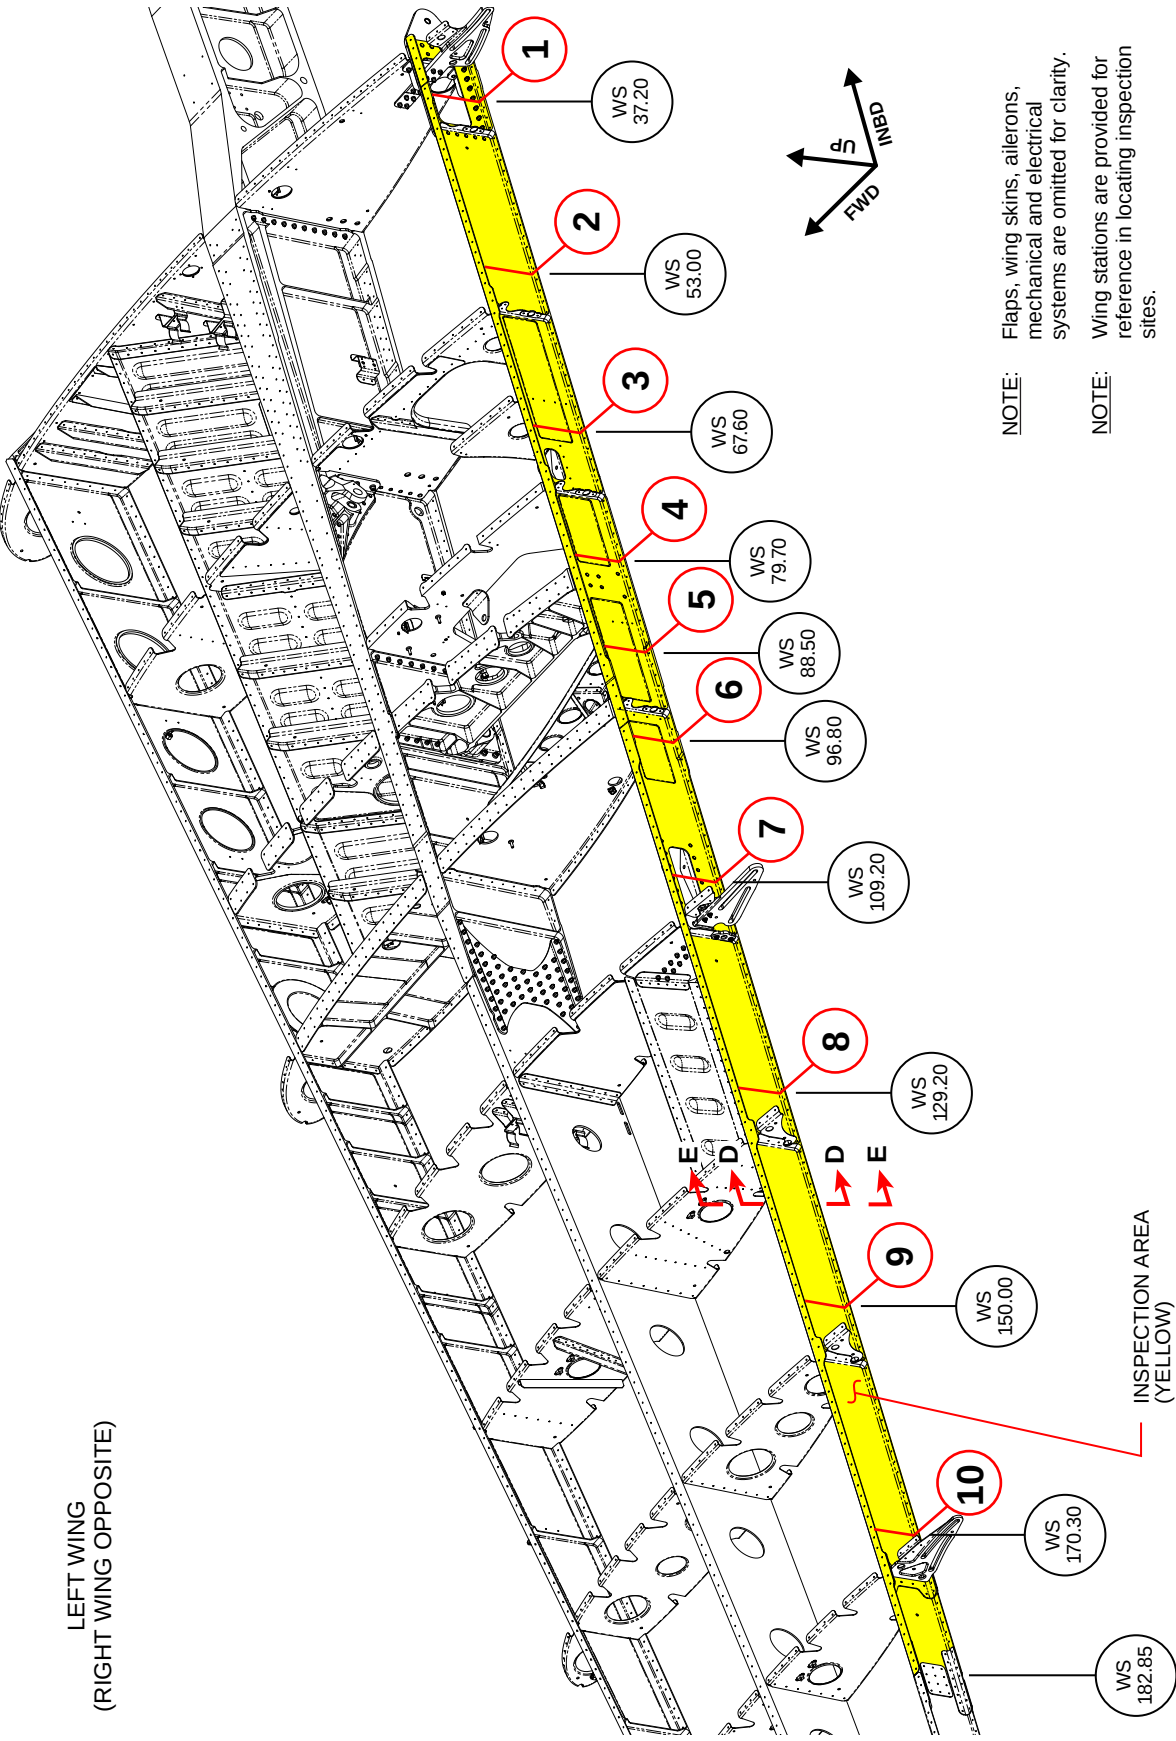
Figure 2, Sheet 1  
Aft Wing Spar – Detailed Inspection

NOTE: The inspection area begins at the aft spar outboard splice at wing station (WS) 182.85 and extends inboard to the wing root. The specific inspection sites within this broad inspection area are defined in Figure 2, marked as 1 through 10, beginning at the wing root.

- c. Locate inspection sites 9 and 10 as shown in Figure 2. At these sites, remove the cured polysulfide fuel tank sealant from the forward surface of the aft spar, along the upper and lower corners, as shown in Figure 2, Section D-D. Remove the sealant along a spanwise length of at least three (3) inches to provide a sealant-free area of at least 1.5 inches on either side of the inspection site.

3. RC – At all inspection sites (1 through 10, as shown in Figure 2), measure the upper corner and lower corner thicknesses, as depicted in Figure 2, Section D–D.

- If all measured thicknesses meet or exceed the minimum original type design thickness requirements stated in Tables 1 and 2, then no modification to the aft spar is required. Proceed to Part V.
- If any measured thicknesses are **less than** the minimum original type design thickness requirements stated in Tables 1 and 2, further evaluation is required. Proceed to Part IV.

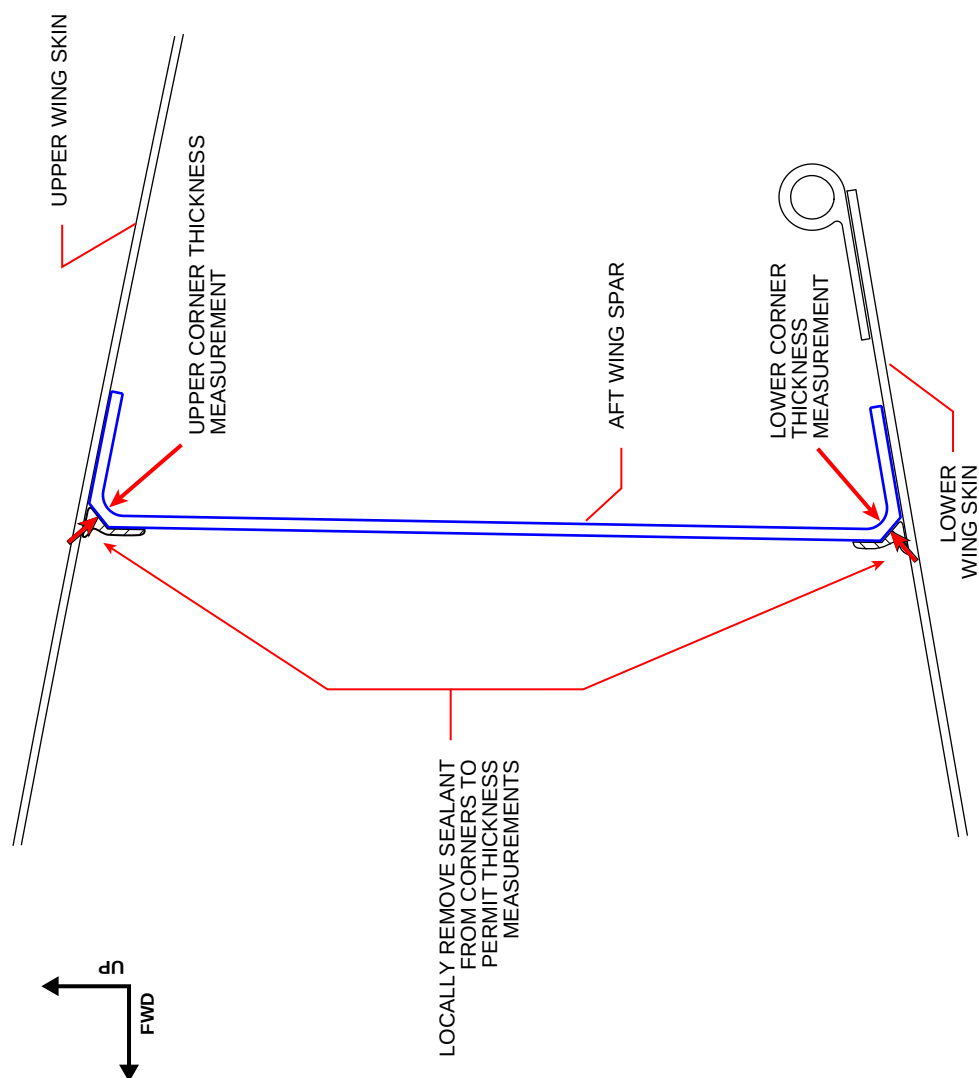
**SECTION D-D**  
TYPICAL CROSS-SECTION OF AFT WING SPAR,  
UPPER AND LOWER WING SKIN

During the aft wing spar inspection and thickness measurements, visually inspect for cracks along the entirety of both the upper and lower corner features as shown in Figure 2, Section D-D (an example of a crack path is shown in Figure 1, Detail B). If a crack is discovered at any time during compliance with this service bulletin, an FAA approved repair must be accomplished prior to next flight. Contact Piper for disposition (contact information follows).

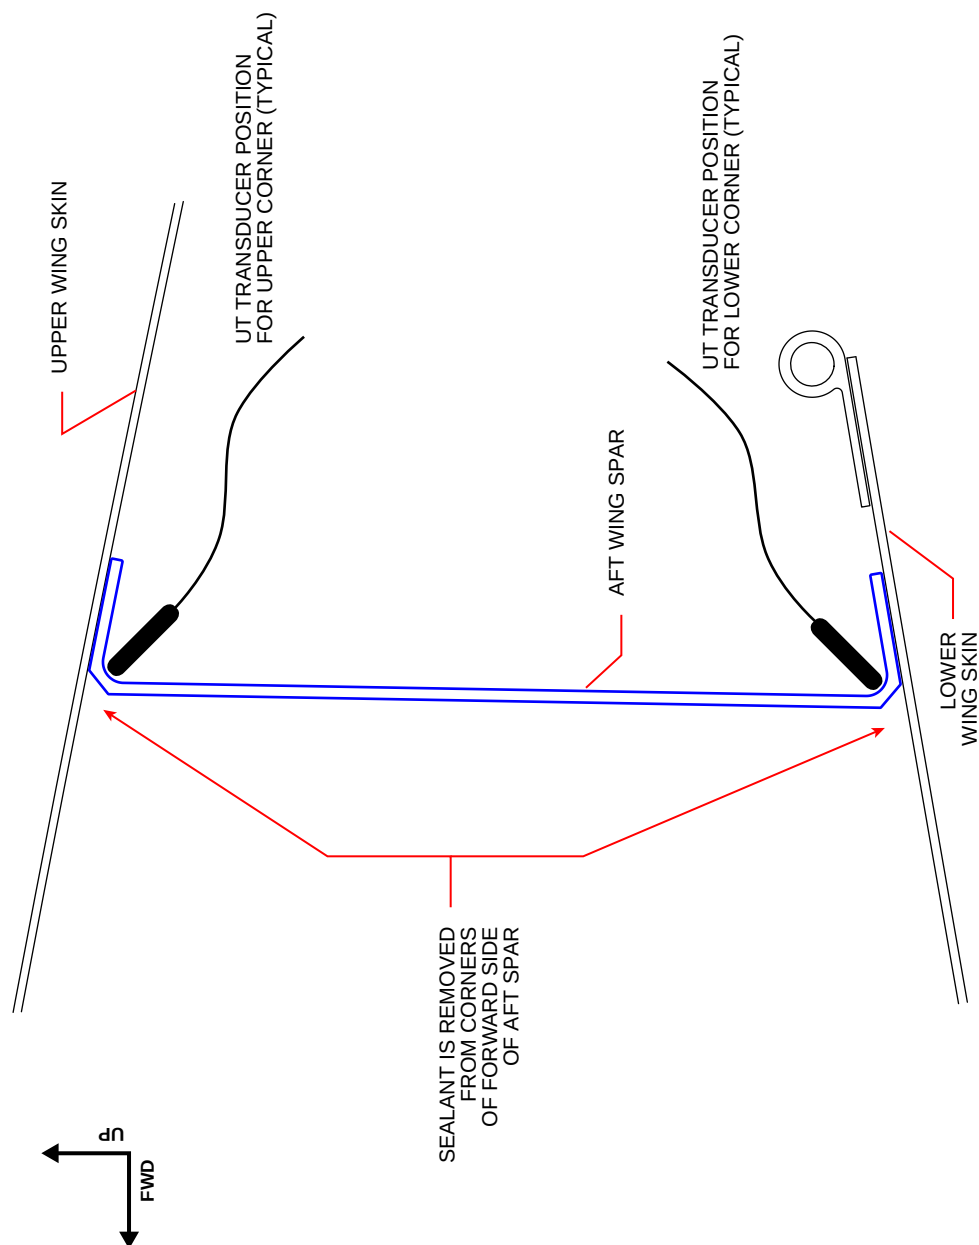
**SECTION E-E**  
TYPICAL CROSS-SECTION OF AFT WING SPAR,  
UPPER AND LOWER WING SKIN

Record measurements in Tables 1 and 2 of the attached inspection form, and compare measured thicknesses against the published minimum original type design thicknesses. (All dimensions are in inches.) At each site, position the transducer probe tip as shown in Figure 2, Section E-E, to measure the corner thicknesses. Observe and document any cracks that are discovered.
