TECHNICAL REPORT NO. LWL-CR-04F70

QUIET, SPECIAL-PURPOSE REVOLVER (QSPR)
DESIGN IMPROVEMENTS (U)

Final Report

AAI Corporation
P.O. Box 6767
Baltimore, Maryland

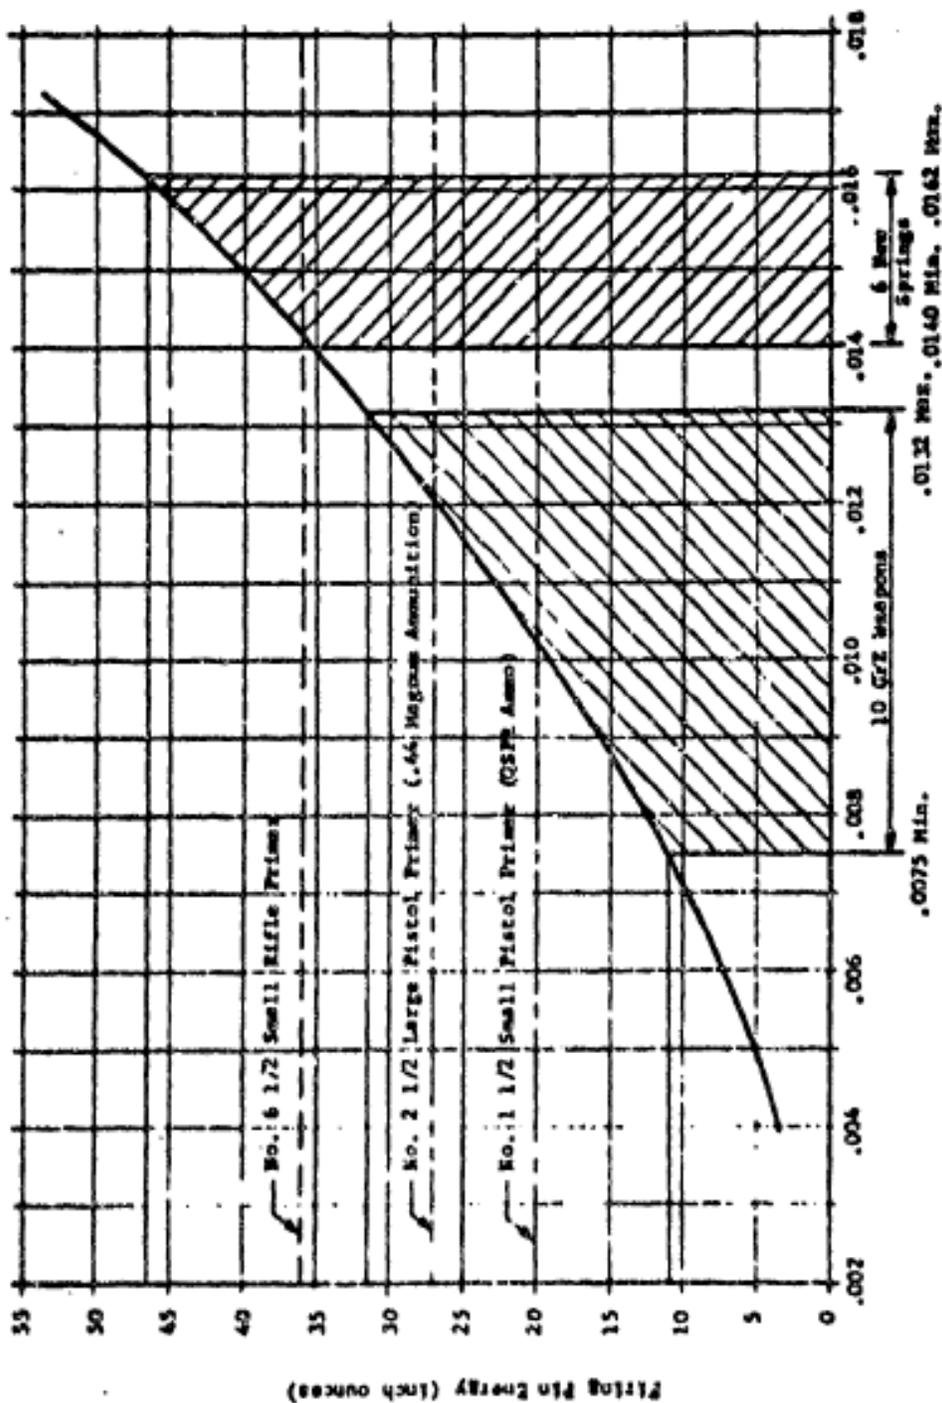
(U) FIGURE 2 - COPPER CRUSHER INDENTATION DEPTH VERSUS FIRING PIN ENERGY FOR 10 GRZ WEAPONS AND 6 NEW MAINSPRINGS

(U) New unused mainsprings were secured from Smith and Wesson and energy levels were recorded for six of them, in a single weapon, and under identical conditions as before. These values are also presented in Figure 2. Note that the significantly higher energies from these new springs all exceed the energy requirements for the large pistol primer. It was concluded at this point that the mainsprings in the ten GPP weapons had definitely experienced a degradation. It was further theorized that severe hammer rebound could cause this detrimental effect by exercising the spring at an extremely high rate. Hammer rebound was known to be prevalent because of the reversing action of the anvil within the round itself. At the onset of firing, the anvil is first driven forward into the primer by the impact of the firing pin. Upon round initiation the anvil is then thrust rearward to its initial static position. It is this rearward movement of the anvil against the firing pin that is responsible for the hammer rebound phenomena. Subsequent high speed motion pictures of the mainspring and hammer movements during firing substantiated that the hammer rebounds all the way back in .003 seconds and impacts the weapon frame. However, when compared to the .243 inches of spring travel, a spring velocity of 6.5 feet per second was realized. Thus, it became obvious that the spring velocity during hammer rebound was relatively low, and not a significant factor in spring degradation. It was further observed, however, that noticeable spring oscillation occurred after the hammer impacted the weapon's frame. It is believed that these oscillations occur as a result of the kinetic energy remaining in the spring after the hammer has impacted the frame.

spring was being stressed beyond its yield point when the hammer is fully cocked against the frame (point of maximum spring deflection). These analytical results were subsequently verified experimentally. Three new unused mainsprings were individually installed, again in a single weapon with spring tensioning screw fully seated, and dry cycled by hand cocking the hammer until it contacted the frame 100 times each. Energy measurement, both before and after cycling, indicated the firing pin energies of these three springs were degraded 18.5%, 23.0%, and 37.0%, respectively. Thus, it was concluded that a portion of the energy loss experienced in the ten GFF weapons can be correlated to the fact that the springs were overstressed initially. Furthermore, additional stresses induced into the spring due to hammer rebound (as computed from motion characteristics observed from the high speed motion pictures) could have had a further progressive degrading effect.

(U) Consequently, a dual spring installation was designed consisting of the original mainspring with limited preload so as not to be overstressed, and an additional small compression spring placed between the mainspring and weapon handgrip frame as shown on the following page. The resulting firing pin energy of 34.0 inch ounces, attributable to this secondary or helper spring,

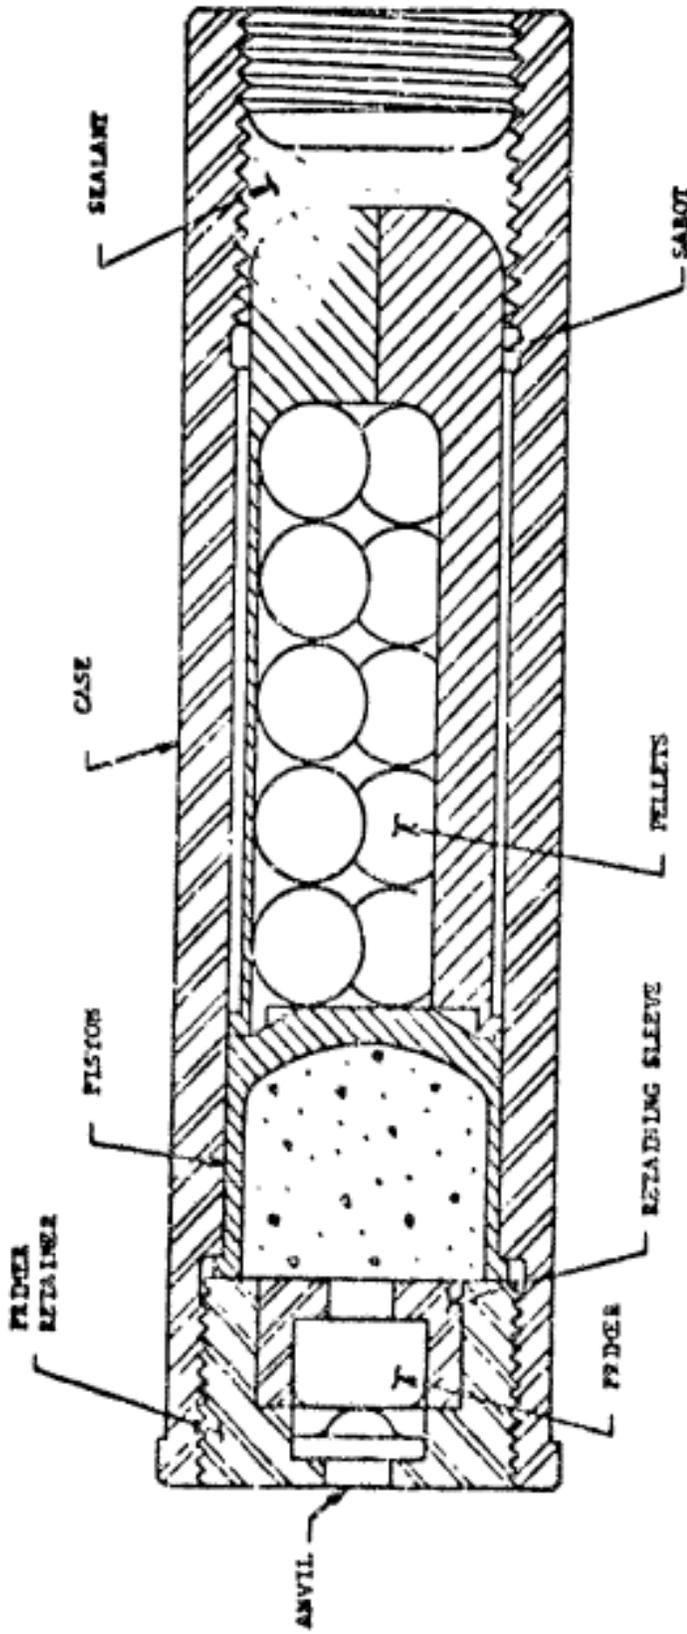
(U) FIGURE 3 AMMUNITION DESIGN AS EVALUATED IN RVN

manufacture or assembly. Examination of the X-rays proved negative, in fact, no appreciable movement of the anvil could be detected. This observation tended to support the theory that the staking lacquer used around the anvil, when allowed to amply cure for several months, could conceivably prevent or retard the anvil's forward movement into the primer and thus absorb most of the available firing pin energy. To check this, primer sensitivity tests were conducted on fifteen unused rounds returned from Viet Nam. The primer assemblies were removed from the rounds, placed in a test fixture, and subjected to a firing pin energy of 20 inch ounces, the manufacturer's recommendation to reliably fire the No. 1 1/2 small pistol primer. All fifteen primers functioned on the first impact even though the firing pin penetration was varied from .045 inches to .030 inches. Although this relatively small sampling was recognized, it became evident at this point that the staking lacquer was not the primary reason for the misfires. Fifteen primer assemblies identified as misfires, were then subjected to the same test with twelve primers functioning and three primers not functioning. The three primers that did not function were each subjected to a second and third impact, again without functioning, although the anvil had moved forward approximately .020 inches in all three cases.

(U) This reasoning led to the development of the redesigned primer installation, henceforth referred to as an improved exposed primer round configuration. A reassessment of the loads in the base plug of the round indicated that heat treatment was not necessary. After a thorough materials search, the maraging steel that was currently used for the base plug was selected, but in the annealed condition. Strength, corrosion resistance and elongation properties dictated this selection. Associated tooling was prepared and various crimping flange configurations were fabricated and subsequently subjected to static tests. The annealed maraging steel crimped exceedingly well and exhibited no evidence of cracking. The most promising configuration was test fired and feasibility was demonstrated when the crimp successfully captivated the primer against all internal pressures and the primer did not blow through when indented directly by the firing pin. A small rifle primer was employed initially because of its increased material

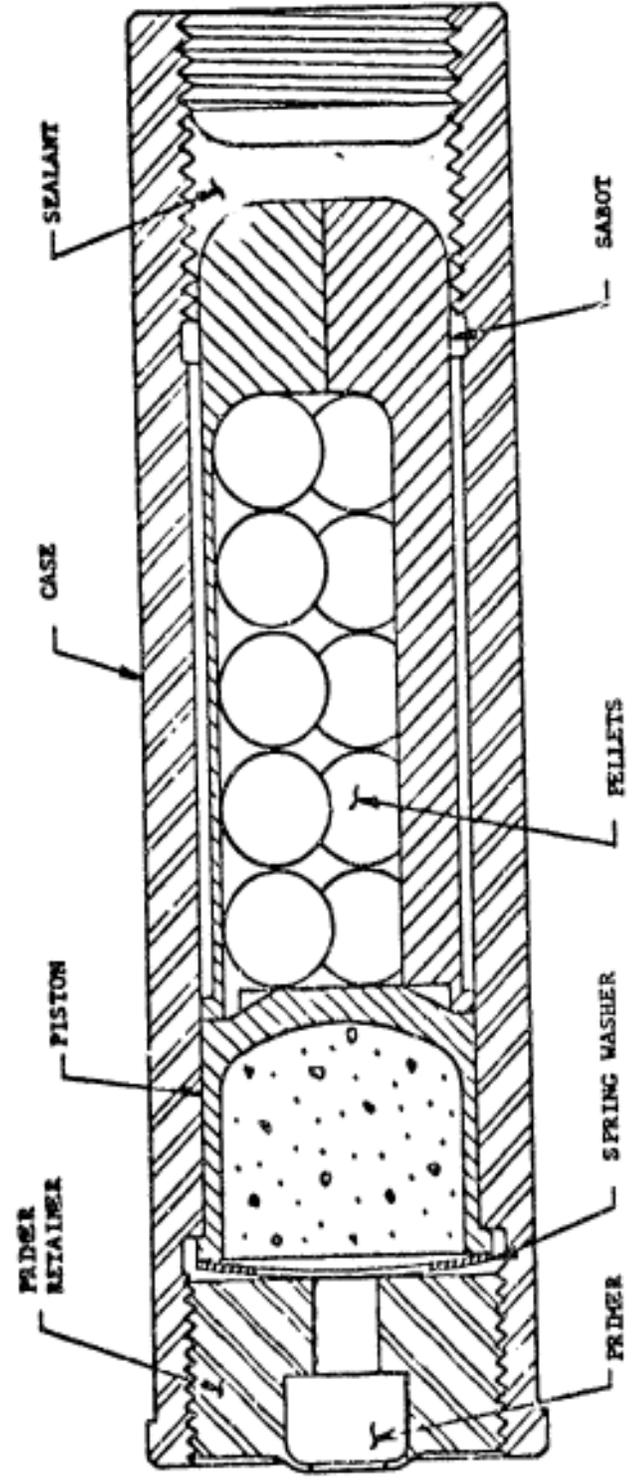
thickness. Reliability data was being sought when a primer blow-through occurred on the 10th and 11th test firings, which also included a 10% propellant overcharge by weight. One out of two subsequent test firings with the standard propellant charge also produced a primer blow-through. Examination of the standard charge round that contained the primer failure revealed that not only had the primer extruded up flush with the top of the crimped surface, as was customary, but had actually extruded around on top of the crimped surface (between the crimped surface and breech face). Up to this time, the base plug was being threaded into the cartridge case until the primer crimp surface was flush or as below flush as practical. It was therefore decided to back the threaded base plug out until the primer crimp surface was always above the base of the cartridge case, assuring direct bearing against the breech face at round setback. This approach was henceforth used exclusively with complete success including test firings with 10% propellant overcharges. The No. 1 1/2 small pistol primer was subsequently repeatedly test fired without any primer failures. This was considered a big breakthrough with regard to weapon firing pin energy requirements, for now the weapon need only to consistently deliver in excess of the 20 inch ounces to reliably fire the No. 1 1/2 primer, rather than energies in excess of the 36 inch ounces to reliably fire the No. 6 1/2 small rifle primer.

(U) FIGURE 4 - IMPROVED QCP AMMUNITION CONFIGURATION (EXPOSED PRIMER)

refinement entailed the inclusion of a curved spring washer, also shown in Figure 4 to keep the piston in intimate contact with the payload, now that the threaded base plug was not positioned against the piston. Improved assembly techniques were devised that facilitated round assembly while consistently positioning the crimped surface of the threaded base plug a known distance above the base of the cartridge case. The assembly fixture was modified to accept a dial indicator and a total tolerance on round overall length of .004 inches was found to be practical. This variation coupled with a total tolerance of the cartridge case of .005 inches, resulted in a tolerance of the crimp projection above the cartridge case of .009 inches. The overall length of the round was fixed a $1.866 \pm .002$ inches and the length of the cartridge case was reduced slightly to yield a crimp projection above the cartridge case of .006 to .015 inches. Also, the more closely controlled overall round length (.004 inches) associated with a more closely controlled dimension on the weapon, from breach face to aft face of barrel, (.002 inches) permitted a reduction in head space. This closer controlled head space of from .003 to .009 inches further enhanced reliability and significantly reduced hammer rebound to one half of its allowable stroke, as evidenced by high speed motion pictures.

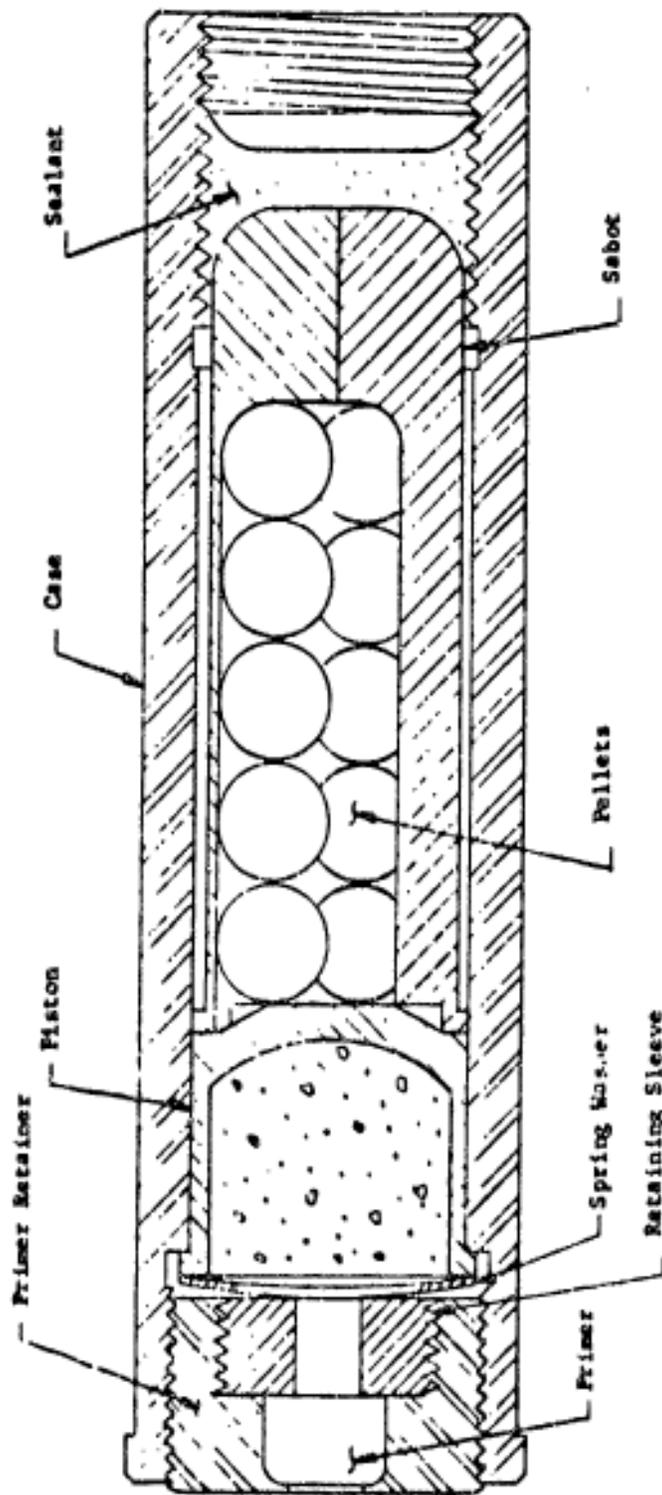
FIGURE 5

(U) Primer crimp failures on the newly redesigned primer retainer were experienced upon firing. This resulted in the primer being pushed out by internal pressure, jamming the ammunition in the chamber and prevention of the weapon cylinder rotation. No failures of this type had been experienced in the development of this design or the lot acceptance tests.

(U) The reason for the material failure was determined to be the stress corrosion cracking characteristics of the marring steel used in primer retainer fabrication. Stress corrosion cracking refers to greatly accelerated corrosion that takes place in certain environments when metals contain certain internal tensile stresses. Depending on the conditions stress corrosion failures can take place from within a few hours to many months. AAI testing of the ammunition had always taken place within two weeks of fabrication while Government tests were made after several months of storage. The internal stresses present in the material as a result of crimping and the fact that a certain amount of

time was required before failure indicates stress corrosion cracking to be the cause of the crimp failures.

(U) QSPR AMMUNITION WITH REDESIGNED PRIMER RETAINER

(U) An improved primer retainer was designed for the ammunition that alleviated the stress corrosion problems encountered with the primer crimp. The exposed primer configuration permitting direct contact with the firing pin was maintained, however, the crimp or swaging operation associated with the stress corrosion cracking of the marring steel was eliminated in its entirety. Twenty (20) primer retainers reflecting this improved design were manufactured and subsequently assembled into twenty GFP rounds of QSPR ammunition, after removal of their existing primer retainers. Development test firings were conducted, in the presence of the Project Officer, to establish the integrity of this redesign. All twenty rounds functioned normally and cylinder rotation problems experienced previously were noticeably non-existent.

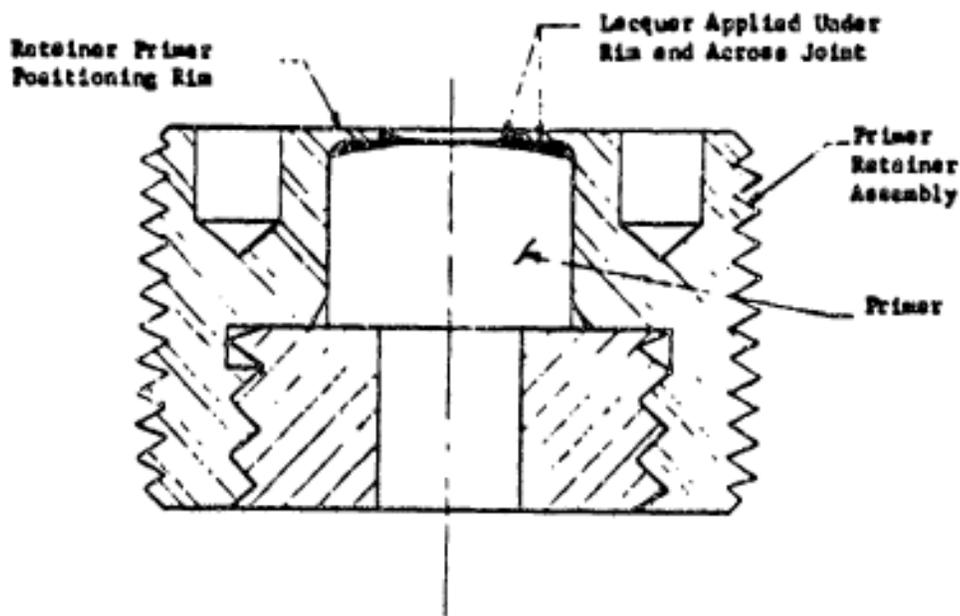
FIGURE 6

(U) Tests of the conditioned rounds revealed a substantial reduction in performance which was attributed to moisture entry in the propellant and primer area of the ammunition. Task Number 6 of Contract No. DAAD05-71-C-0270 was entered into to correct the moisture entry problem and conduct additional environmental conditioning of seventy-five (75) corrected rounds of QSPR ammunition.

(U) IMPROVED PRIMER SEALING TECHNIQUE

(U) Improvements in the sealing around the primer were thought to be sufficient to correct the problem. The original technique for sealing was accomplished by application of lacquer after the primer was pressed into place against the locating rim on the primer retainer. To improve the seal in this area the lacquer was applied just before the primer was pressed against the rim. This allowed lacquer to flow around the end of the primer and provide sealant between the primer and rim as well as on the exposed joint between the primer and primer retainer rim. Figure 6 shows the location of the lacquer sealant in the corrected design.
