TECHNICAL REPORT NO. LWL-CR-04F70

QUIET, SPECIAL-PURPOSE REVOLVER (QSPR)
DESIGN IMPROVEMENTS (U)

Final Report

AAI Corporation
P.O. Box 6767
Baltimore, Maryland

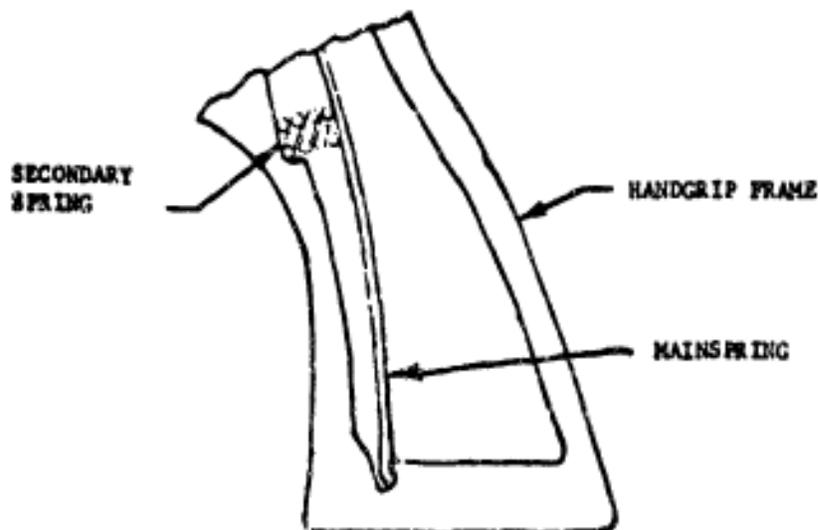
spring was being stressed beyond its yield point when the hammer is fully cocked against the frame (point of maximum spring deflection). These analytical results were subsequently verified experimentally. Three new unused mainsprings were individually installed, again in a single weapon with spring tensioning screw fully seated, and dry cycled by hand cocking the hammer until it contacted the frame 100 times each. Energy measurement, both before and after cycling, indicated the firing pin energies of these three springs were degraded 18.5%, 23.0%, and 37.0%, respectively. Thus, it was concluded that a portion of the energy loss experienced in the ten GFF weapons can be correlated to the fact that the springs were overstressed initially. Furthermore, additional stresses induced into the spring due to hammer rebound (as computed from motion characteristics observed from the high speed motion pictures) could have had a further progressive degrading effect.

(U) Continued experimentation revealed that if the spring tensioning screw was restricted such that the springs were not overstressed initially, then no energy degradation occurred due to dry cycling. However, in so doing, the available firing pin energy was of the magnitude of 22.5 inch ounces, and afforded little excess of the 20 inch ounces required to reliably fire the No. 1 1/2 primer. Such a small safety factor on firing pin energy was considered incompatible with the primary objective of this program, namely to increase round functioning reliability by eliminating misfires.

(U) Consequently, a dual spring installation was designed consisting of the original mainspring with limited preload so as not to be overstressed, and an additional small compression spring placed between the mainspring and weapon handgrip frame as shown on the following page. The resulting firing pin energy of 34.0 inch ounces, attributable to this secondary or helper spring,

represents a 30% energy increase and effectively provides a significant safety factor over the 20 inch ounces required. Subsequent monitoring of this improved dual spring installation through repeated dry cycling and actual live firing tests revealed no spring energy degradation whatsoever. Also of extreme importance is the fact that not a single misfire occurred throughout this program with the advent of the dual spring installation and other ammunition design improvements discussed later in this report.
